BELZONA INCREASES EFFICIENCY OF MULTI-STAGE PUMP

ID: 5342

City water utility multi-stage pump.

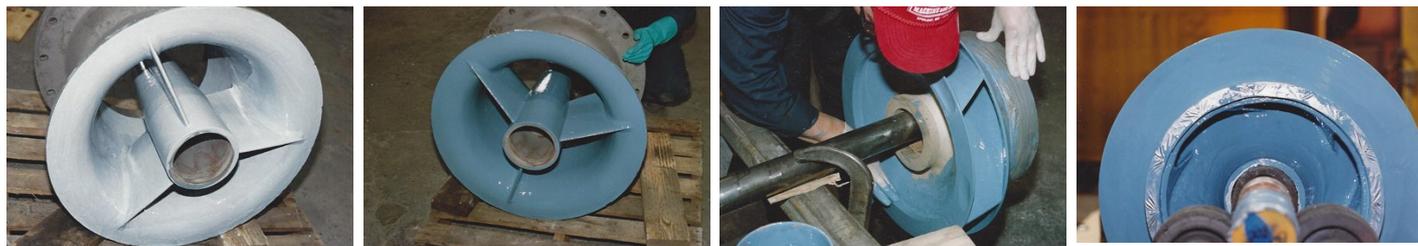
Photograph Descriptions

- * Pump end with first coat of Belzona 1341 ,
- * Pump end with second coat of Belzona 1341 ,
- * Applying Belzona 1341 to pump impeller ,
- * Pump impeller ready for reassembly ,

The application was carried out in accordance with Belzona Know-How System Leaflet CEP-10. The pump casings and impellers were grit blasted and then two coats of Belzona 1341 were brushed on.

By using Belzona 1341, they will see a 7% increase in efficiency for this pump. The return on investment will only take 7 months. Belzona 1341 will also provide long-term corrosion protection.
