# Protection of a chemical tank at very high temperature

ID: 5362

Industry: *Chemical & Petrochemical*  
Application: *TCC-Tanks and Chemical Containment Areas*  
Substrate: *Steel*  
Products: *\* Belzona 1591 (Ceramic XHT Metal) ,*

Customer Location: *Lavéra, France*  
Application Date: *May 2012*

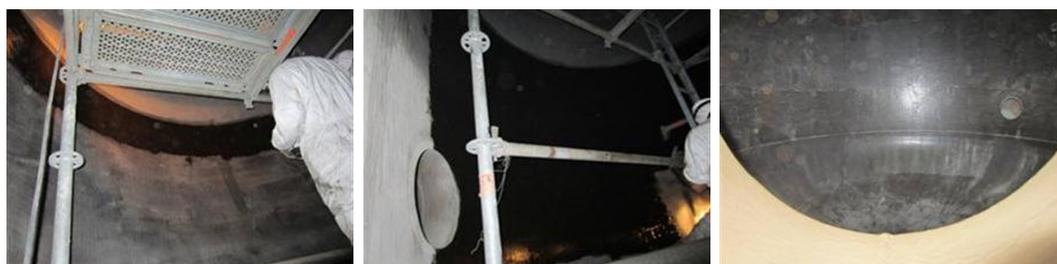
*Tank made of steel can be easily attacked by chemicals at high temperature (165°C)*

- \* Blasted surface, ,
- \* On-going application, ,
- \* Finished application ,

Application realised in accordance to Belzona system leaflet TCC-5. After degreasing and blasting, Belzona 1591 was applied in a one-coat system (between 600 and 800µm).
