# BELZONA REBUILDS PAPER MILL CYCLONE

**Industry:** Pulp & Paper  
**Application:** TCC-Tanks and Chemical Containment Areas  
**Substrate:** Carbon steel  
**Products:** \* Belzona 1311 (Ceramic R-Metal) ,  
\* Belzona 1321 (Ceramic S-Metal) ,

Internal lining repair of a cyclone that feeds a hog fuel boiler.

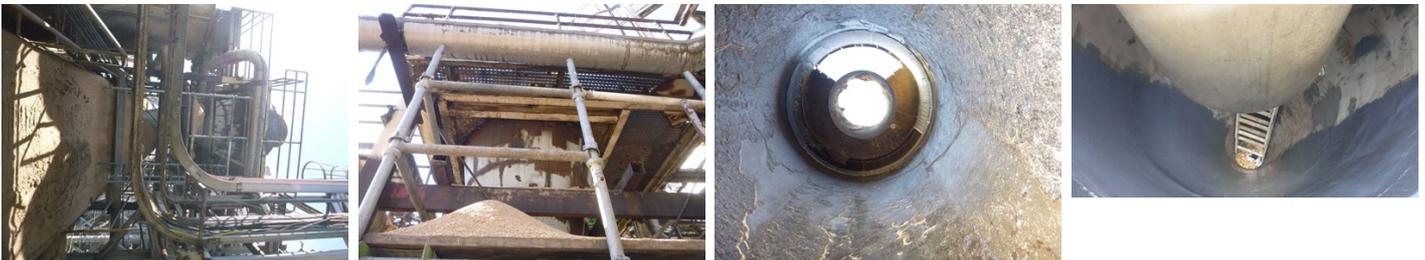
Erosion had progressed over the years to a point of significant material loss and holes emerging as hog fuel is metered through the cyclone.

- \* Cyclone with lost material piled up around its base ,
- \* Welded patches can be seen from outside ,
- \* Pack rust and scale in the interior of the cyclone seen from below ,
- \* Belzona 1311 applied as fillers and 1st coat of Belzona 1321 is applied ,

As usual, downtime was restricted and we had not been able to see interior surfaces prior to shutdown. Considerable pack rust was encountered, which required needle gunning prior to abrasive blasting. Belzona 1311 & 1321 were hand applied, as confined space offered no room for spray equipment use. Belzona 1311 was used to fill the voids and pits before a coat of Belzona 1321 was applied.
