# BELZONA REPAIRS AND PROTECTS HOUSING

ID: 5395

Industry: *Marine*  
Application: *SOS-Ships and Offshore Structures*

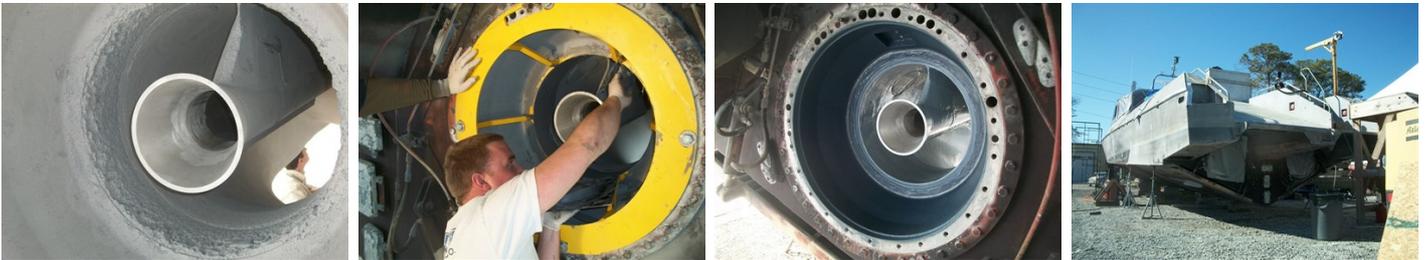
*Severe erosion and pitting of the jet drive transom housings threaten the service life cycle of the equipment and reduce the efficiency of the jet drive system.*

- \* Blasted port transom housing ,
- \* Mold is in place and the Belzona rebuilding metal is being applied to return the housing to the original dimensions and contours ,
- \* The completed port transom coated with Belzona 1321. The molded jet drive clearances are perfect ,
- \* Stern view of the Special Operations Craft and the transoms (covered by tarps) ,

Erosion and corrosion caused a major loss of metal in the jet drive transom housing.

The transom housing was blasted to a near white metal finish. A former was manufactured to mold the critical clearances to 1-2 mm between the removable jet drive and the boat transom housing. Once the rebuilding and molding was completed, two coats of Belzona 1321 were applied.
