# BELZONA REPAIRS AND PROTECTS ROOF FROM LEAKS

ID: 5397

Application: RPA-Roof Problem Areas

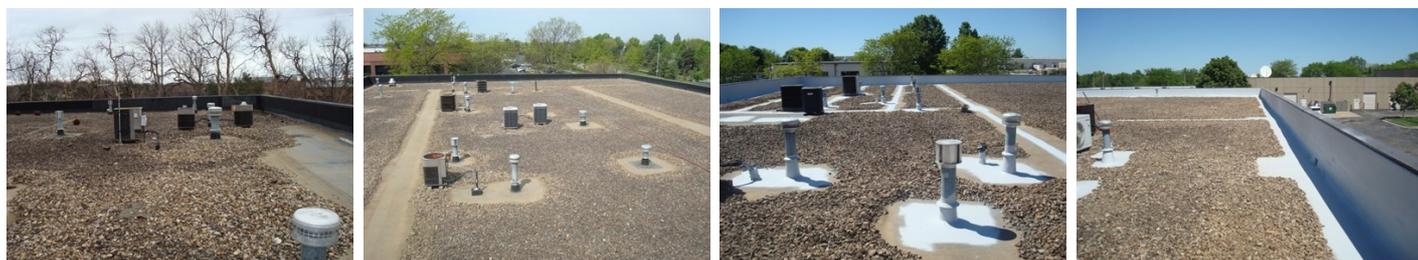
All five roofs of this commercial business park had numerous water leaks and interior water damage.

- \* Overview of the roof ,
- \* Areas to be treated ,
- \* Belzona 3111 applied to designated areas, including possible penetrations throughout ,
- \* Completed applications, including the seams of the entire perimeter ,

The rock ballast was moved to expose all joints, seams, penetrations, parapets and patches. These known problem areas then received the fully reinforced Belzona 3111 system remediation. The application was carried out in accordance with Belzona Know-How System Leaflet RPA-1.
