BELZONA REFURBISHES A WASH PIT

ID: 5404

Industry: Buildings & Structures
Application: FPA-Floor Problem Areas
Substrate: Concrete
Products: * Belzona 4111 (Magma Quartz),
* Belzona 2211 (MP Hi-build Elastomer),

Customer Location: Bellingham, WA, USA
Application Date: May 2014

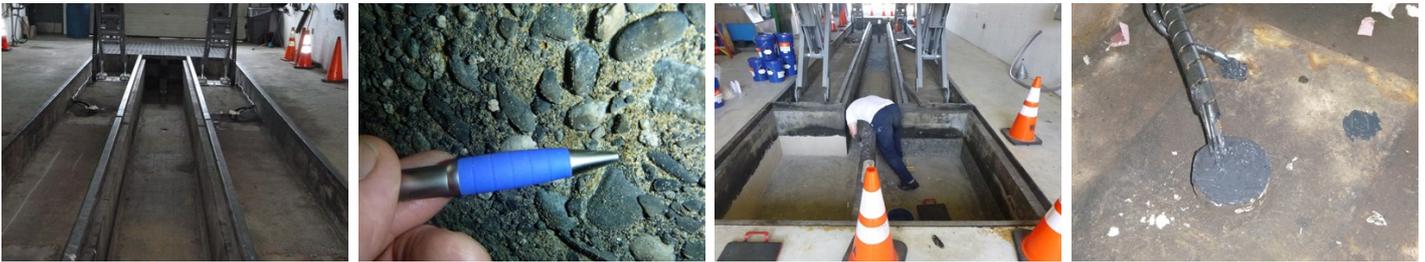
Photograph Descriptions

The structure had no previous coating and there was significant spalling at and below the waterline. Several electrical glands in the pit required resealing to prevent leakage into adjacent equipment vaults.

- * Wash pit overview ,
- * Erosion & spalling evident at waterline and below ,
- * Hand troweled application of Belzona 4111 over Belzona 4911 (Magma TX Conditioner) ,
- * Belzona 2211 applied into cable glands ,

The application was carried out in accordance with Belzona Know-How System Leaflets FPA-1 and GSS-4. Thorough steam cleaning completed prior to hand troweling. Belzona 4111 was applied onto vertical sidewalls. Belzona 2211 was applied into pipe glands after cleaning and conditioning to prevent further leakage from wash pit into adjacent equipment vaults
