BELZONA REPAIRS STEEL PIPE ELBOW AT A POWER PLANT

ID: 5423

Application: SHM-Solids Handling Machinery

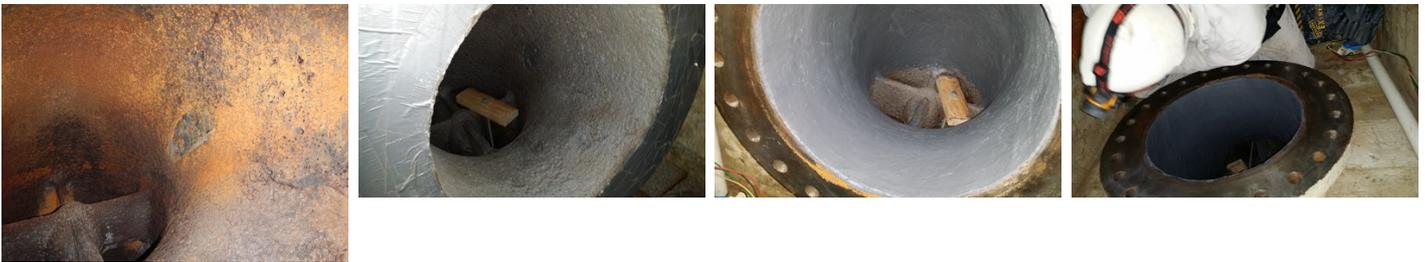
Photograph Descriptions

Very old pipe elbow needed to be replaced due to high corrosive pitting. It was close to having holes through to the concrete foundation of the historic building (power house).

- * 1. Pipe elbow before the application ,
- * 2. Pipe elbow after Sponge-Jet Blasting ,
- * 3. Pipe elbow after application of Belzona 1311 ,
- * 4. Pipe elbow after application of Belzona 1321 ,

Sponge-Jet abrasive grit blasting was used to prepare the metal surface. Application was carried out in accordance with Belzona Know-How System Leaflet SHM-8.

Belzona provided the client with the solution to eliminate the outside environment to being able to affect the steel substrate. Due to time and the elements the pipe elbow was deteriorating. After preparation of the corroded metal surface using Sponge-Jet abrasive grit blasting, Belzona 1311 was applied and Belzona 1321 was then applied in two coats. This created a barrier and a smooth surface, and saved the client costs of having to retrofit a new pipe elbow, foundation alteration of a historic building, environmental challenges, and labor.
