# SHOWER REPAIRED AND PROTECTED WITH BELZONA

ID: 5429

Customer Location: Dredge Boat, South Louisiana, USA  
Application Date: May 2014

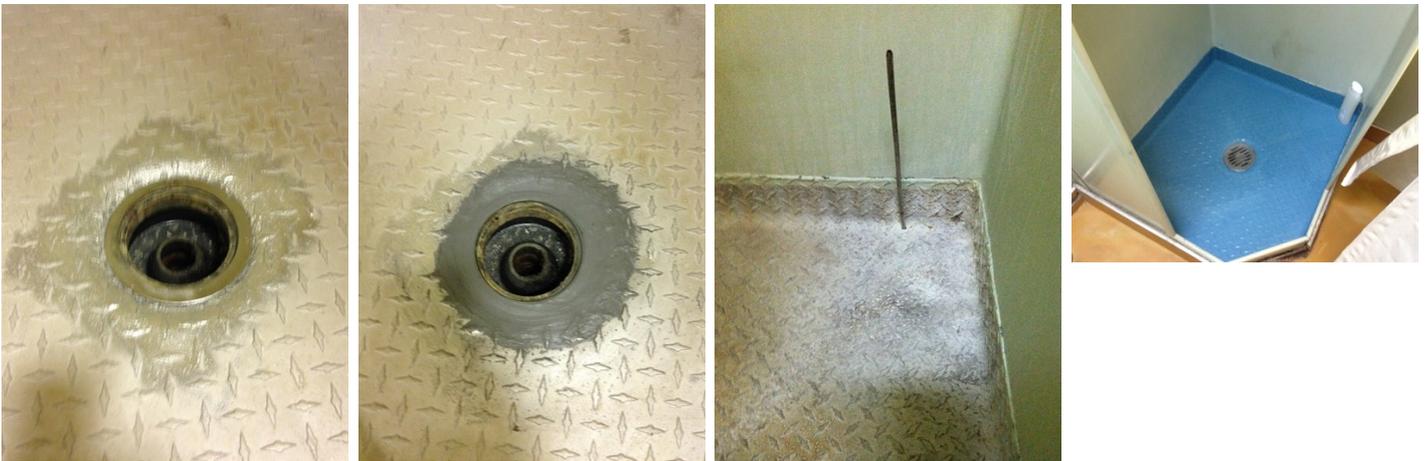
Crew was using cleaner on shower that was not supposed to be used on aluminum. Cleaner was eroding the metal. Shower floor made of aluminum and drains are brass. Bimetallic corrosion was occurring at drain. So, basically 2 different problems were occurring and destroying the shower floor.

- \* 1. Drain prepared for Belzona application ,
- \* 2. Belzona metal filled in areas where corrosion was occurring ,
- \* 3. Holes had appeared from using the chemical cleaner ,
- \* 4. Application completed ,

Application was carried out in accordance with a modified version of Belzona Know-How System Leaflet FPA-1.

Showers are now more aesthetically pleasing plus corrosion issues have been stopped. The only alternative was to replace the

shower floor which would have been very expensive. The Belzona repair per shower is about \$150.00. Cheif Engineer has had great success with Belzona products and felt confident in using Belzona 1341 for the coating.
