# BELZONA RENEWS HOG ELBOW

ID: 5464

Industry: *General Industry*  
Application: *SHM-Solids Handling Machinery*

Customer Location: *British Columbia, CA*  
Application Date: *October 2014*

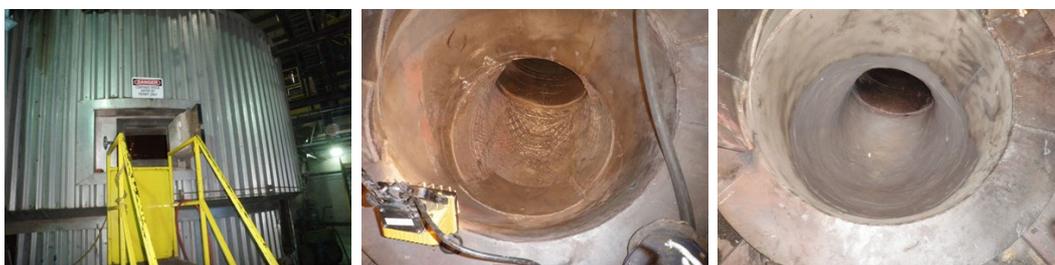
*The elbow wears where at one point it was criss-crossed with an AR weld. Unfortunately, the fuel feed would hang up on the AR weld pattern, causing the auger to work much harder.*

- \* The burn chamber exterior and access door. ,
- \* The interior of the elbow from above. The Belzona product from the original application 10 years ago is still visible. ,
- \* Completed application. ,

The application was carried out in accordance with Belzona Know-How System Leaflet SHM-8. The surface was grit blasted; Belzona 1812 was applied by applicator and it was then overcoated with Belzona 1321 for smoothness.

This elbow is one of three originally surfaced in 2004 with Belzona 1812, which was found to not only protect the elbow, but significantly reduce auger torque as well. 10 years later this elbow needed a new coating and Belzona was asked to renew the application.
