BELZONA PROTECTS AGAINST HOT SULPHURIC ACID

Industry: Chemical & Petrochemical
Application: TCC-Tanks and Chemical Containment Areas
Substrate: Tile and Brick
Products: * Belzona 4131 (Magma-Screed) ,
* Belzona 4341 (Magma CR4) ,

Customer Location: Chemical Company, Warrington, UK
Application Date: September 2014

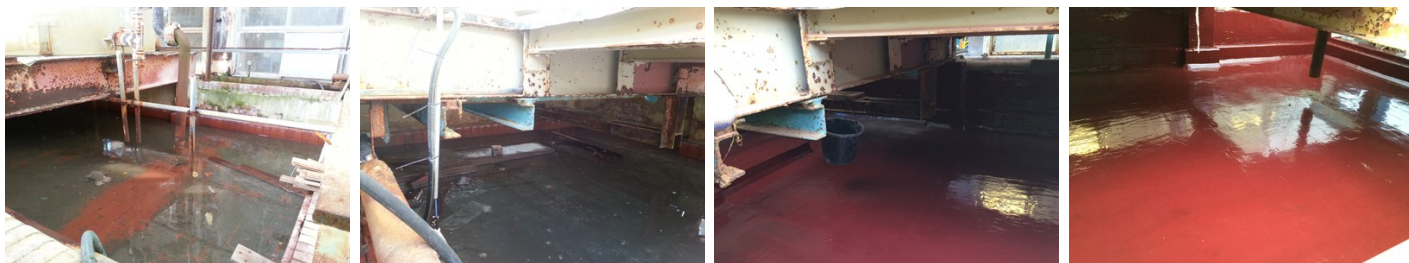
Photograph Descriptions

The tiles were on the base of the bund and a couple of inches up the walls. As the standing water levels were above the tiles, it was leaking through the bricks. The tank inside was storing 77% sulphuric acid at 70°C. It was therefore decided to coat the bund.

- * Damaged bund area ,
- * Damaged bund area ,
- * & 4. Completed application ,

The application was carried out in accordance with Belzona Know-How System Leaflet TCC-15. Belzona 4131 was used to create fillets at the horizontal and vertical junctions before Belzona 4341 was applied to protect the entire area.
