# BELZONA PROVIDES NON-SLIP SURFACE AT SCHOOL ENTRANCE.

Application: FPA-Floor Problem Areas

Customer Location: School, Derbyshire

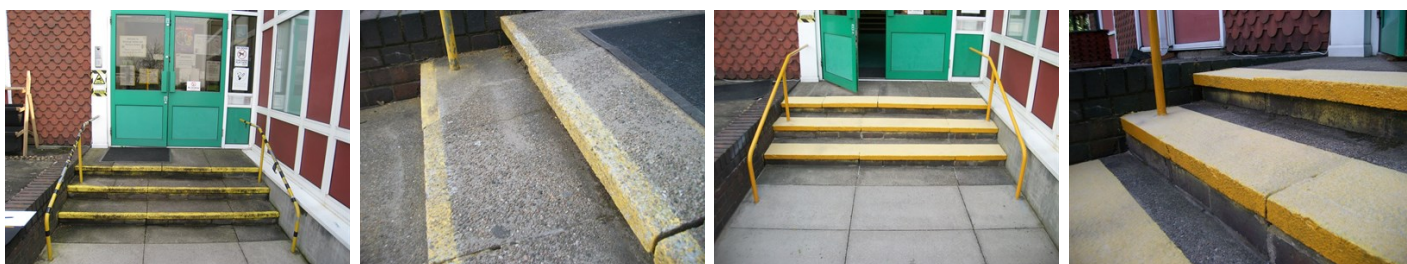
Steps presented a slip hazard to pupils, staff and visitors when entering and exiting the school.

\* 1. Damaged Steps 2. Damaged steps- close up 3. Completed Application 4. Completed Application - close up ,

Worn Steps

The application was carried out in accordance with Belzona System Leaflet FPA-8. Belzona 9221 was encapsulated in the Belzona 4411 and applied in an even coat.

The school had used Belzona 4411 in the past and were pleased with the results and therefore chose Belzona again for this application. The entire application was completed in one day. The Belzona 4411 yellow provides a visual guide to the step nosings as well as a hard wearing non-slip surface.
