# BELZONA PREVENTS ROOF LEAKS ACROSS HOUSING ESTATE

ID: 5525

Industry:	Buildings & Structures	Customer Location:	Housing Association, Loughborough, UK
Application:	RPA-Roof Problem Areas	Application Date:	September 2014
Substrate:	Asphalt, Lead Flashing		
Products:	* Belzona 3111 (Flexible Membrane) , * Belzona 3911 (PSC Surface Conditioner) , * Belzona 3921 (GSC Surface Conditioner)

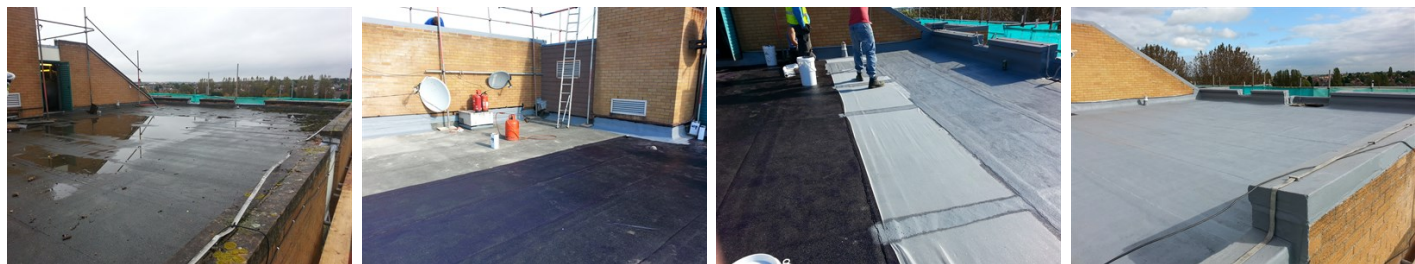
### Photograph Descriptions

- <div>
  - \* Roof without any form of protection ,
  - \* Half of the roof coated with Belzona 3911 ,
  - \* Belzona 9311 laid out and Belzona 3111 being applied ,
  - \* Finished application ,</div>

Application was carried out in accordance with Belzona Know How System Leaflets RPA-8 and RPA-10. All flashings were cleaned, and loose chippings on the felt were removed. Belzona 3911 was applied to the asphalt and Belzona 3921 applied to the lead flashings. This was followed by two coats of Belzona 3111 along with Belzona 9311 laid into the first coat.
