# BELZONA PROTECTS TOOTHPASTE FACTORY FLOOR

Customer Location: Pharmaceutical Company, Maidenhead, UK

Application: FPA-Floor Problem Areas

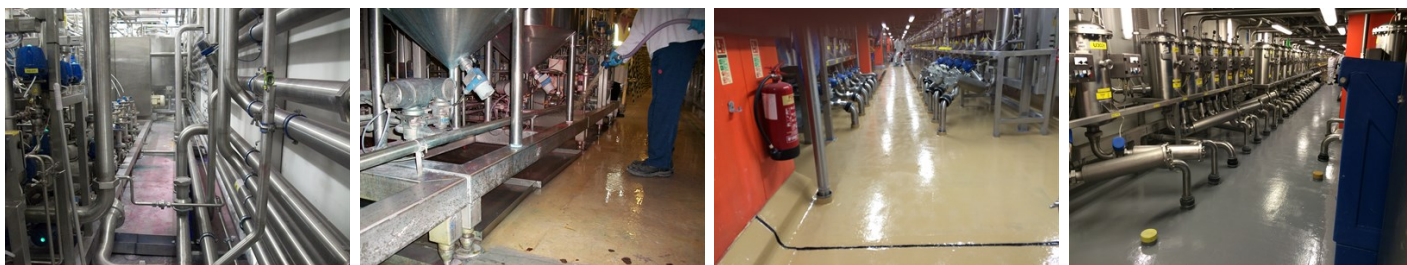
The originally applied protective coating on the floor had failed, due to the spillage of Flavour Oils and the use of caustic soda to clean the room daily. As a result, water/cleaning fluid was leaking through the floor and into the packing area below. The existing polyurethane coating was in most part still intact and showed good adhesion to the steel/aluminum chequer plate. The area's which have failed are where the floor is most exposed to the chemicals i.e. drain areas and flow paths. Access to some of the areas was restricted by pipe work and plant.

- \* Damaged Floor ,
- \* Washing to remove dye ,
- \* 1st coat application ,
- \* 2nd coat application ,

The application was carried out in accordance with Belzona Know How System Leaflet FPA-3. All sound areas of the existing coating were left in place as total removal was not an option.
