# Belzona Protects Fans From Abrasion

Industry: *General Industry*  
Application: *FBC-Fans, Blowers and Compressors*

Customer Location: *Tobacco company, Egypt*  
Application Date: *February 2002*

Substrate: *Steel*  
Products: *\* Belzona® 1812 (Ceramic Carbide FP) ,*

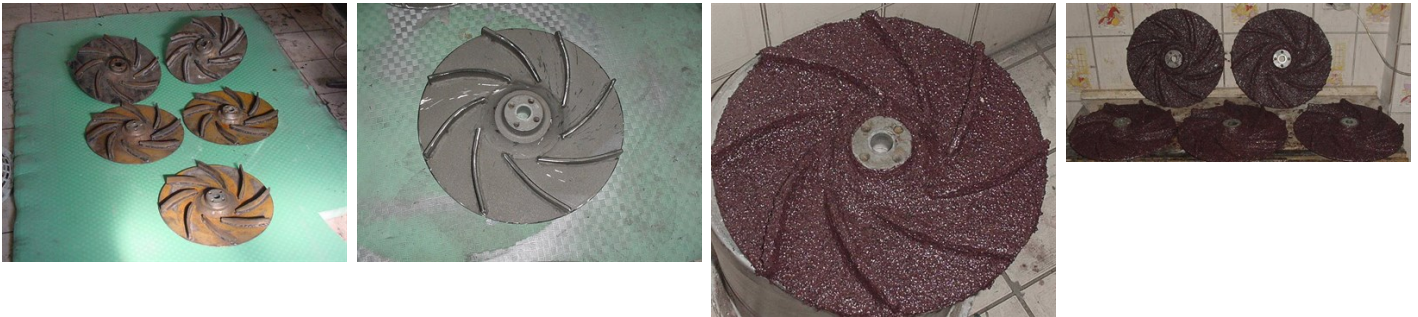
## Photograph Descriptions

*The fans need to be protected from strong abrasion of tobacco which has worn the fans out in only three months.*

- \* General view of tobacco suction fans ,
- \* Fans following surface preparation ,
- \* Fans coated with Belzona® 1812 (Ceramic Carbide FP) ,
- \* Five fans were protected ,

Application was carried out in accordance with Belzona Know-How System Leaflet FBC-2.

The tobacco suction fans were worn out and replaced every three months. After coating the fans with Belzona® 1812 the fans provided over a year of service before they are touched up. Other fans in the tobacco facility are coated regularly.
