Belzona Protects Fans From Abrasion

ID: 554

Industry: *General Industry*
Application: *FBC-Fans, Blowers and Compressors*

Customer Location: *Tobacco company, Egypt*
Application Date: *February 2002*

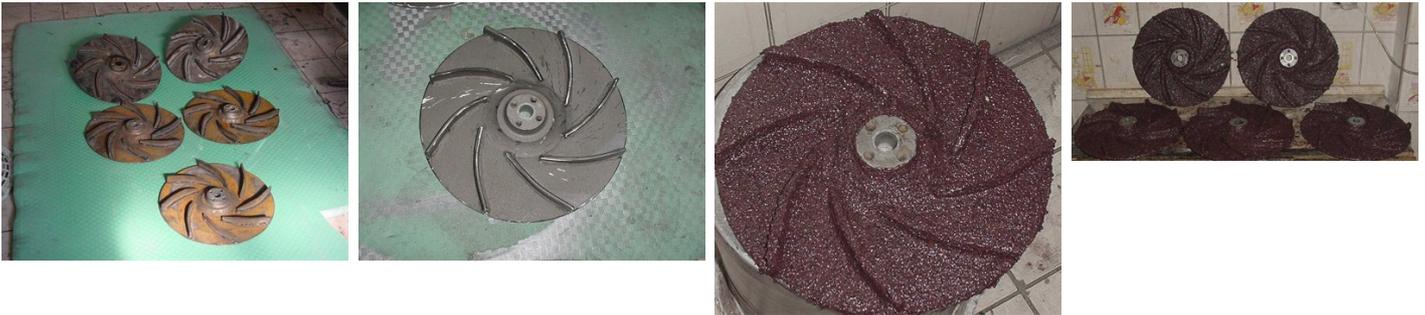
Photograph Descriptions

The fans need to be protected from strong abrasion of tobacco which has worn the fans out in only three months.

- * General view of tobacco suction fans ,
- * Fans following surface preparation ,
- * Fans coated with Belzona® 1812 (Ceramic Carbide FP) ,
- * Five fans were protected ,

Application was carried out in accordance with Belzona Know-How System Leaflet FBC-2.

The tobacco suction fans were worn out and replaced every three months. After coating the fans with Belzona® 1812 the fans provided over a year of service before they are touched up. Other fans in the tobacco facility are coated regularly.
