# BELZONA REPAIRS TO CREAMERY MILK RECEPTION FLOOR AREA

**Industry:** Food & Drink  
**Application:** FPA-Floor Problem Areas  
**Substrate:** Concrete  
**Products:** \* Belzona 4131 (Magma-Screed) ,  
\* Belzona 4521 (Magma-Flex Fluid) ,

**Customer Location:** Creamery, Stranraer, Scotland  
**Application Date:** November 2014

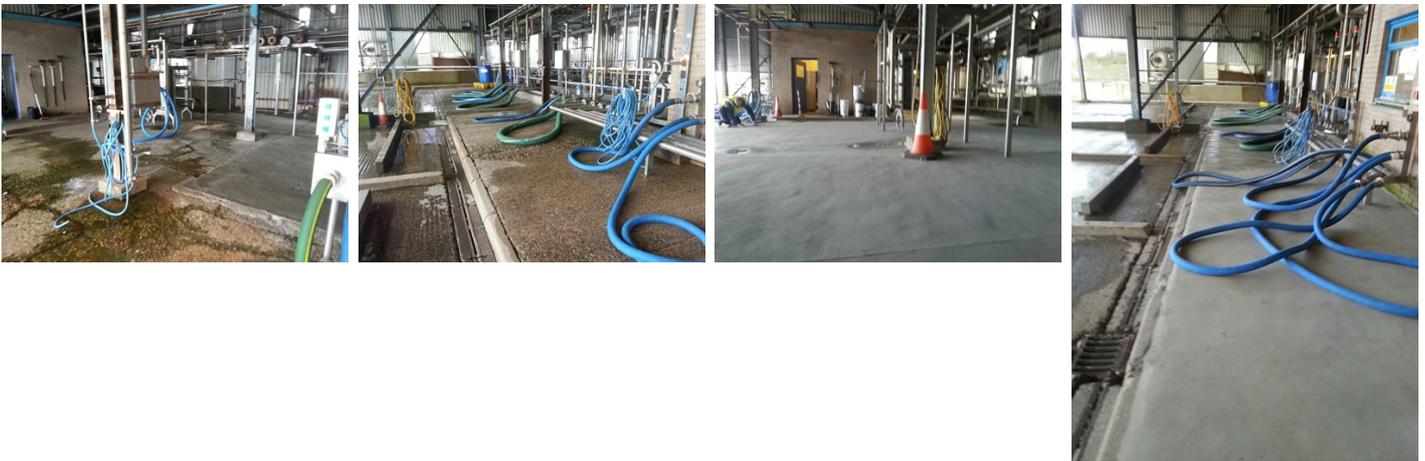
The materials had to be applied and cured in this short time frame. Over the years, the concrete floor had deteriorated due to wear, abrasion and chemical attack from the milk and cleaning fluids used. In some areas, the concrete has become cracked, and in others, it has worn down resulting in an uneven surface. An expansion joint was also in need of replacement.

- \* Cracks in the concrete floor ,
- \* Damage from loading product ,
- \* Application of Belzona 4131 ,
- \* Completed application ,

The area was mechanically prepared and power washed to bring out any ingrained chemicals. The application was carried out in accordance with Belzona Know-How System Leaflets FPA-1 and FPA-6.

Digging out the entire area and replacing it with concrete would have taken longer than the shutdown allowed. Additionally, it would have caused disruption to the work carried out around the area. Belzona 4131 provides a hard wearing chemical resistant surface.
