WATER REPELLENT BELZONA TREATMENT FOR SWIMMING POOL WALLS

Customer Location: *Local Council Swimming Pool,
Gloucestershire, UK*

Application: *WPA-Wall Problem Areas*

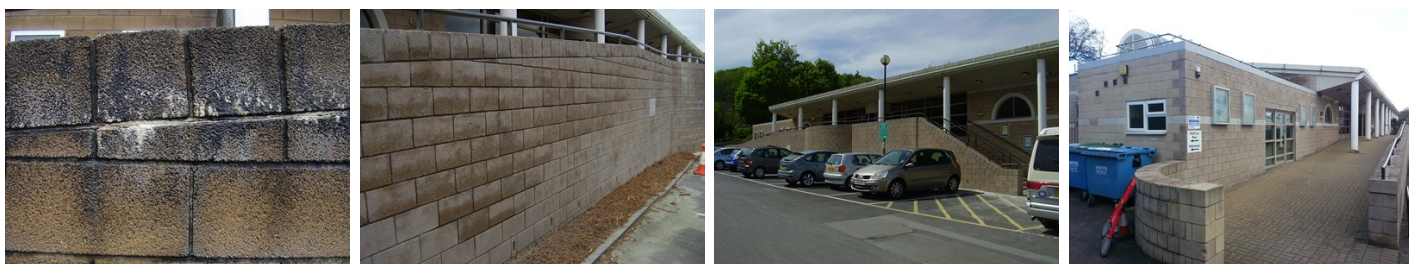
Photograph Descriptions

Water penetration into the building fascia was causing salt to be washed out of the bricks, visibly discolouring the wall and leaving the swimming pool looking worn and tired.

- * Concrete blocks stained with salt ,
- * Repair area lightly blasted ,
- * Application of Belzona 5122 ,
- * Application revisited after 7 years in service ,

The application was carried out in accordance with Belzona Know-How System Leaflet WPA-8. A number of blasting systems were used in the attempt to remove the salt. The system that provided the best results was a system used in the marine industry to clean off the undersides of boats, called the Farrow System (high pressure water/sand blast system). Once the salt had been removed, Belzona 5122 was applied by the council's internal maintenance team via a pump up hand spraying system and a brush application around details, such as pipes, windows and doors.

work. Blasting was carried out before opening hours and the water repellent treatment was carried out in 2 stages to ensure minimum disruption to the public. The system has lasted the test of time for the council and they are more than happy with the results. No salts or staining on the concrete block walls is visible even after 7 years.
