BELZONA OFFERS ANTICORROSIVE AND PEELABLE PROTECTION FOR FLANGES

Industry: Oil & Gas
Application: GSS-Gaskets, Seals and Shims
Substrate: Carbon Steel
Products: * Belzona 3411 (Encapsulating Membrane) ,
* Belzona 8411 ,
* Belzona 9311 (Reinforcing Sheet) ,

Customer Location: Bahia, Brazil
Application Date: January and February, 2015

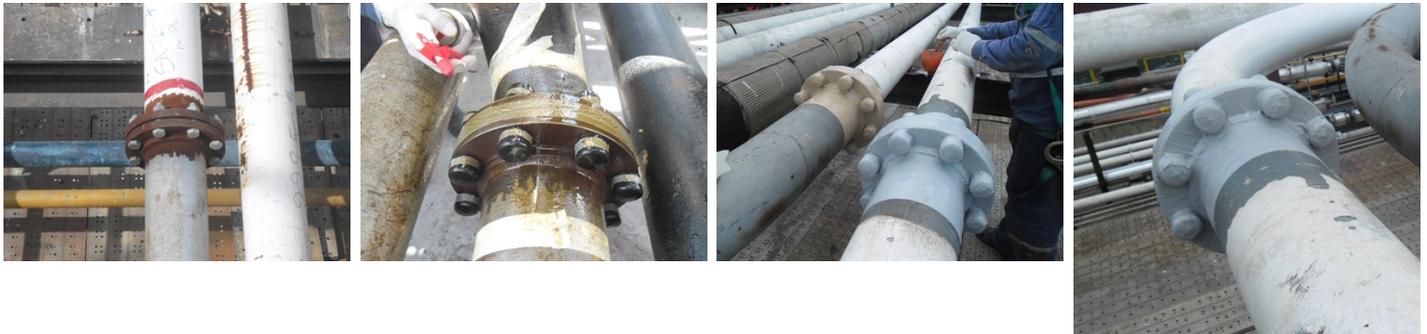
Photograph Descriptions

The complex geometry of the flanged joints facilitates the occurrence of problems, such as crevice corrosion in the void between the two flange faces and galvanic corrosion, where the use of different metals can create serious consequences.

- * Corroded flange ,
- * Application of Belzona 8411 ,
- * Application of the second coat of Belzona 3411 (Grey) over the first coat (Beige) ,
- * Completed application ,

The application was carried out in accordance with Belzona Know-How System Leaflet GSS-11. The surface preparation was carried out manually with emery cloth according to the standard SSPC SP2/SP3, equivalent to St2/St3. After the surface was prepared and cleaned, the joints were sealed between the flange faces with tape and Belzona 8411, a corrosion inhibitor, was applied. After the protection of bolts with caps, Belzona 3411 was applied in two coats, utilizing Belzona 9311 in the circumference and in the

extremities of the flanges. At the end, a visual inspection was carried out.
