# BELZONA REPAIRS FILTER PLATES IN MINING INDUSTRY

ID: 5568

Industry: Mining & Quarrying  
Application: VPF-Valves, Pipes and Fittings  
Substrate: Polypropylene  
Products: \* Belzona 1311 (Ceramic R-Metal),  
\* Belzona 1321 (Ceramic S-Metal),

Customer Location: Mine, Guatemala  
Application Date: November 2013

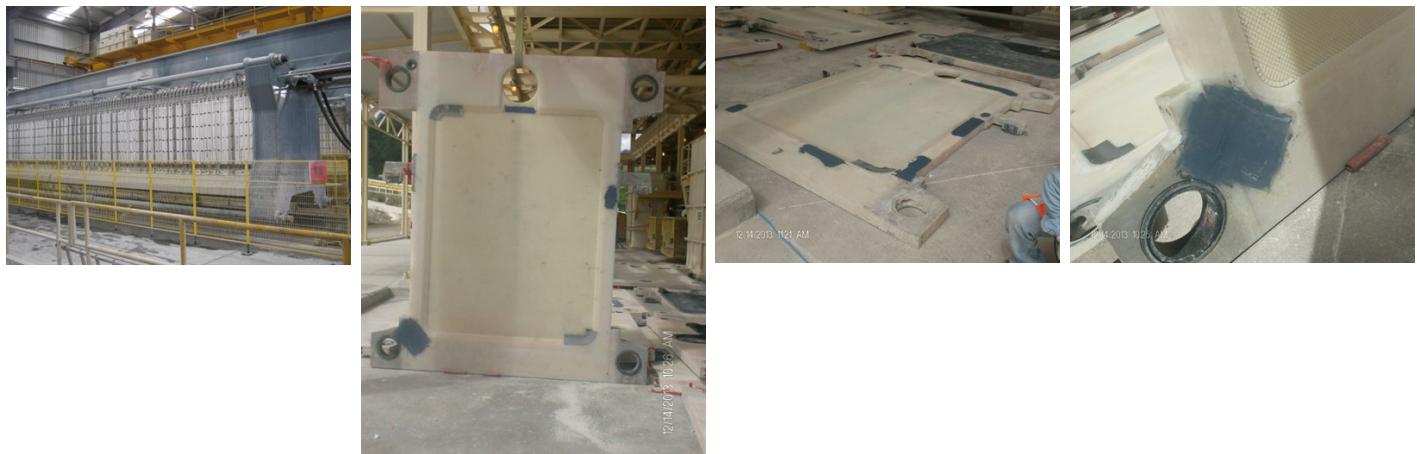
- \* View of the size of the filter and its 86 plates installed ,
- \* Completed plate application ready to be installed back into the filter ,
- \* Completed plate application ready to be installed back into the filter ,
- \* Close up view of the application of Belzona 1311 and Belzona 1321 ,

The application was carried out in accordance with a modified Belzona Know-How System Leaflet VPF-8. The plates were manually repaired with Belzona 1311 and Belzona 1321 in the damaged areas.
