# BELZONA RESIN CHOCKS FOR DREDGER BOILER

ID: 5582

Customer Location: *Port Operator, Middlesbrough, UK*  
Application Date: *April 2015*

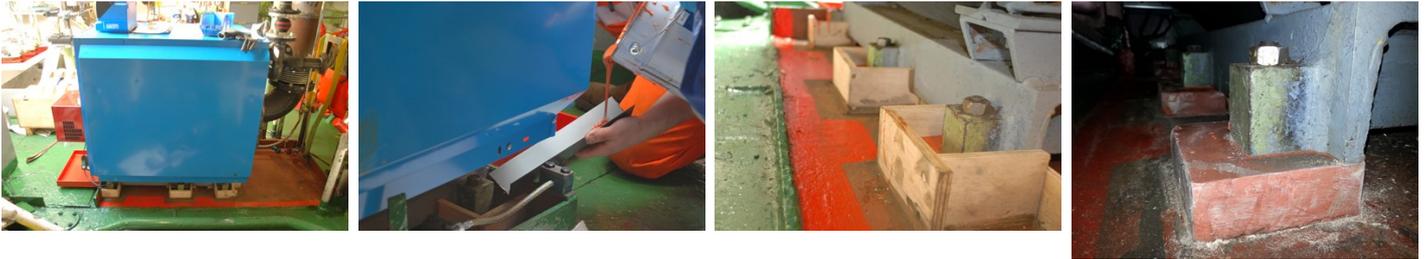
- \* The boiler set in place ,
- \* Pouring Belzona 7111 into the prepared area ,
- \* Product curing around bolts ,
- \* Completed application with dams removed ,

The application was carried out in accordance with Belzona Know-How System Leaflet GSS-12. The boiler was set into place using jacking bolts, and dams were built around each of the individual bolts. Belzona 7111 was then poured into the prepared areas using a small section of steel as a runway due to the difficult access. The thickness of the pour was just over 2 inches, so a solidifier reduction was used.
