BELZONA RESIN CHOCKS FOR DREDGER BOILER

ID: 5582

Industry: *Marine*
Application: *GSS-Gaskets, Seals and Shims*
Substrate: *Steel*
Products: ** Belzona 7111 (Marine Grade),*

Customer Location: *Port Operator, Middlesbrough, UK*
Application Date: *April 2015*

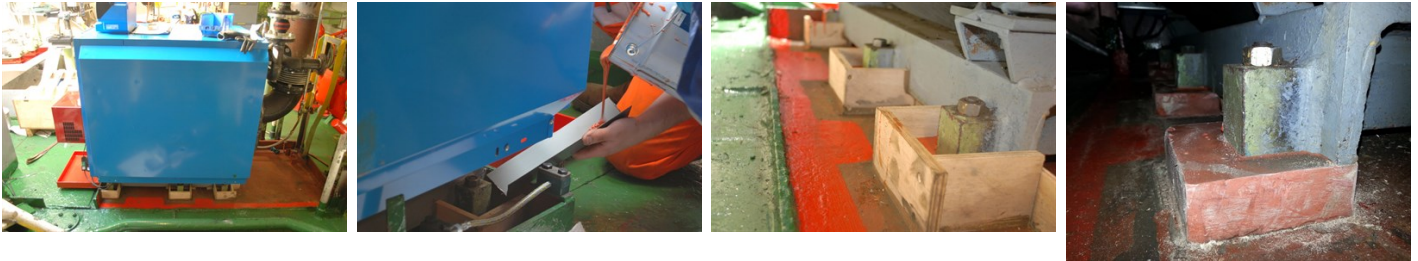
Photograph Descriptions

- * The boiler set in place ,
- * Pouring Belzona 7111 into the prepared area ,
- * Product curing around bolts ,
- * Completed application with dams removed ,

The application was carried out in accordance with Belzona Know-How System Leaflet GSS-12. The boiler was set into place using jacking bolts, and dams were built around each of the individual bolts. Belzona 7111 was then poured into the prepared areas using a small section of steel as a runway due to the difficult access. The thickness of the pour was just over 2 inches, so a solidifier reduction was used.
