# Doubler Plates bonded with Belzona to Forecastle Deck

ID: 5584

Industry: Marine  
Application: TCC-Tanks and Chemical Containment Areas  
Substrate: Steel  
Products: \* Belzona 1151 (Smoothing Metal) ,

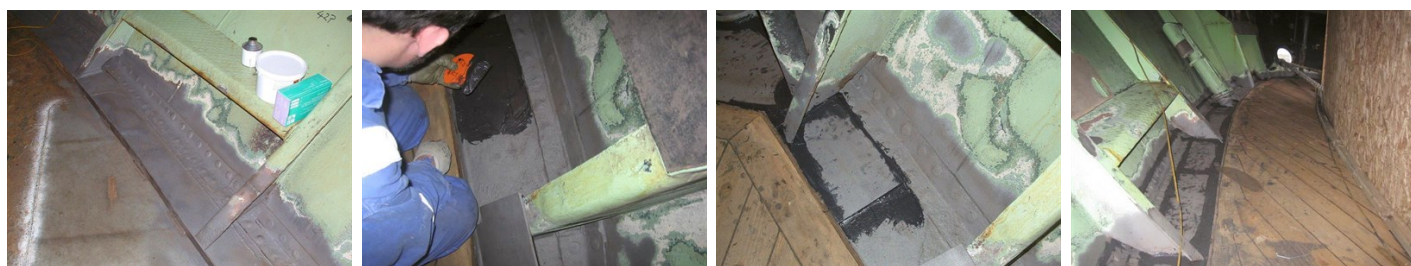
The width of exposed deck plating has had thickness measurements carried out throughout its life and has shown signs of thinning. They needed to replace the lost metal and reintroduce the corrosion allowance, as the guttering is classed as part of the green deck (structural integrity of the deck), welding would require the area to be heat treated post welding to relieve any stress created by the welding.

- \* 1. View of Forecandle & "Gutterway"
- \* 2. Application of Belzona 1151 ,
- \* 3. Plate bonded to the deck ,
- \* 4. Completed application ,

The application was carried out in accordance with Belzona System Leaflet TCC-3. The doubler plates have been prepared to a minimum of 5mm thick plate which are 1300mm in length and 350mm width. The Belzona 1151 (Smoothing Metal) was applied to the plate, and the corresponding area of the deck. The plate was gently bonded on to the deck until all of the excess Belzona 1151 has been exuded out from around the full circumference of the plate.

The Belzona 1151 was a cold repair, no pre or post heat treatment required. Plates were in 100% contact with the deck, welding

was only circumferential. No specialist equipment required, giving a quicker turnaround.
