# Belzona Repairs Rubber Gear Casting

ID: 560

Customer Location: Cooking vessel manufacturer, Egypt  
Application Date: December 2001

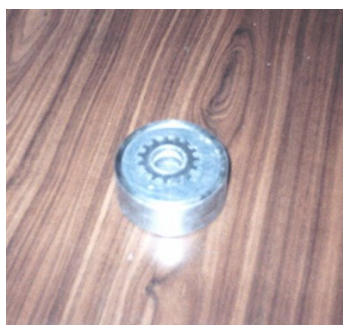
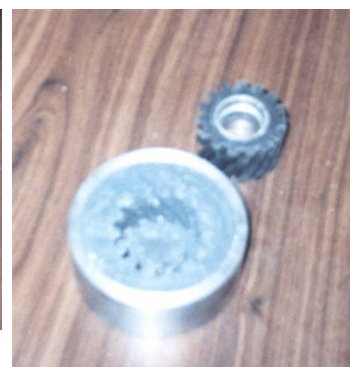
- \* The rubber section which needed to be cast ,
- \* Preparing the mold ,
- \* Rubber mold completed ,
- \* The cast gear and the mould ready to cast another new gear ,

The rubber gear was produced at only 25% of the cost of an imported gear. The mould was also produced using Belzona. The new gear was ready for use in only one day saving significant time over importation.
