# BOW THRUSTER TUNNEL PROTECTED

ID: 5600

Industry: *Marine*  
Application: *SOS-Ships and Offshore Structures*

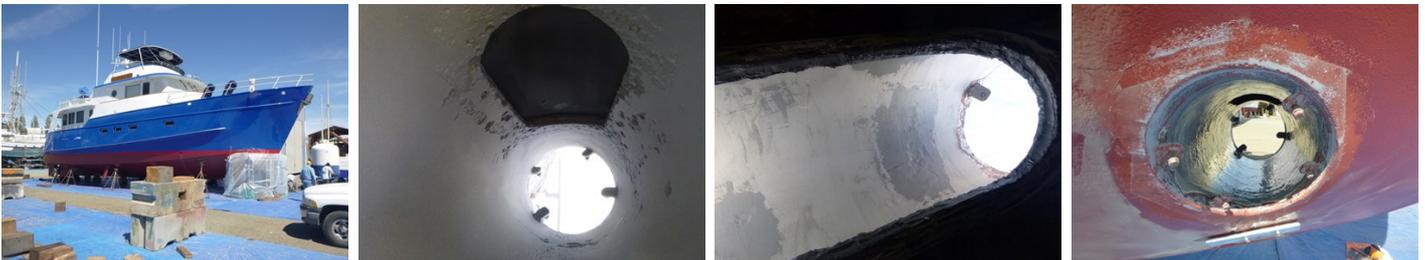
*Thruster tunnel was pitted and eroded in areas near thruster propulsion unit. Bi-metallic corrosion was also a component of the deterioration.*

- \* Vessel out of water with hutch built around thruster tunnel for containment. ,
- \* Tunnel prepared with abrasive blast. Note significant pitting on upper surfaces. ,
- \* Belzona 1311 applied to pitted areas as seen from inside vessel. ,
- \* Two coat application of Belzona 1321. Bottom paint will be lapped over Belzona 1321 at tunnel edge. ,

Tunnel was prepared by first removing several layers of bottom paint and then abrasive blasting to achieve a 3 mil profile. Belzona 1311 was applied to fill the pitting and erosion prior to the application of 2 coats of Belzona 1321.
