# BELZONA SEALS SPIRIT BUND

ID: 5602

**Customer Location:** Distillery, Glasgow, Scotland  
**Application Date:** October 2014

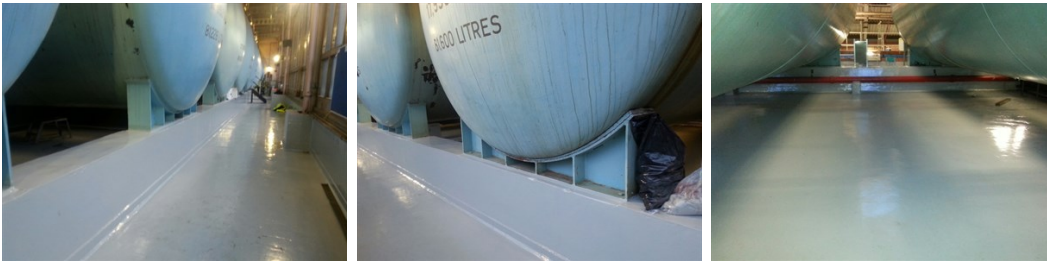
New walls were built from engineering brick around the area. The complex geometry & many possible leak points made sealing the bund a challenge.

- \* One of the Vat plinths ,
- \* Belzona 4131 fillets around the plinth ,
- \* Completed application with Belzona 5811 to seal the area ,

The application was carried out in accordance with Belzona Know-How System Leaflet TCC-15. The floor was prepared with grinders before Belzona 4131 and Belzona 4141 were used to repair defective areas. Fillets were created with Belzona 4131 at all corners around the bund. Finally, two coats of Belzona 5811 were applied to completely seal the area.
