UPGRADED BELZONA LINING SPECIFICATION FOR SEA WATER PUMP

ID: 5604

Customer Location: Power Plant, Taiwan
Application Date: October 2014

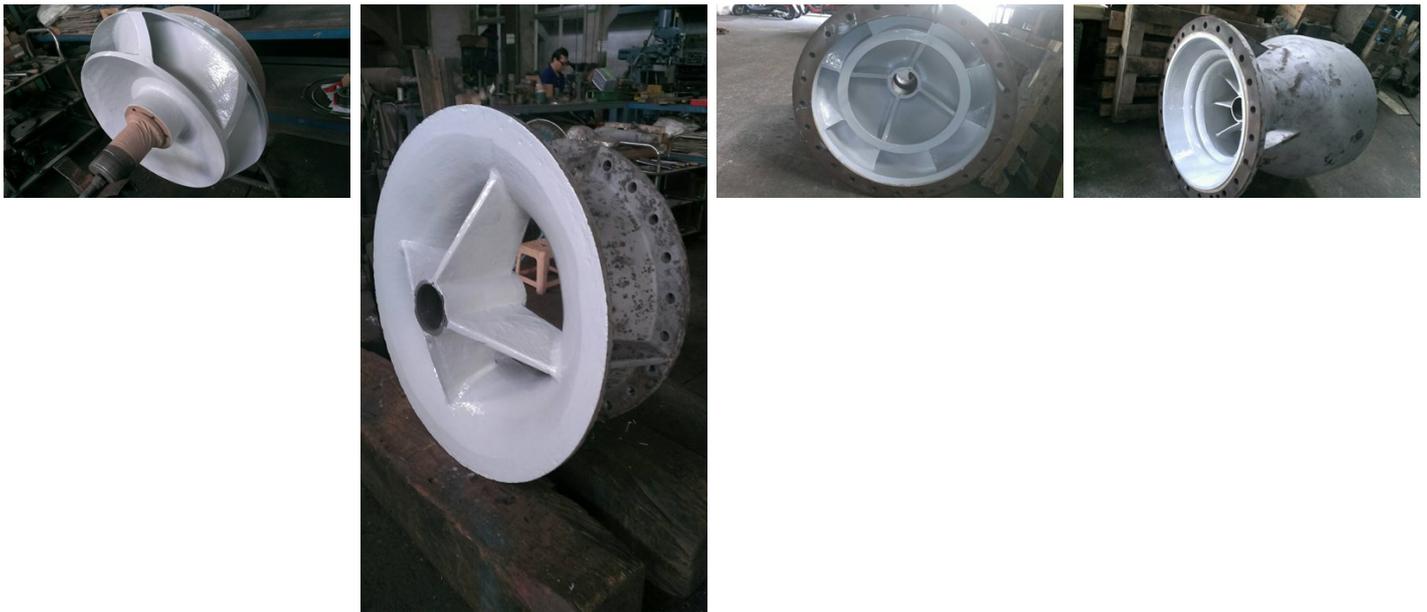
Photograph Descriptions

Superior erosion resistant lining required to protect the pump from further erosion-corrosion.

- * Completed application on impeller ,
- * Completed application on casing ,
- * Completed application on casing ,
- * View of completed application on cooling water pump ,

The application was carried out in accordance with Belzona Know-How System Leaflet CEP-3.

Belzona 1321 had been previously applied in their sea water cooling pumps with excellent performance. After introducing Belzona 1331 as a better erosion resistant coating than Belzona 1321 but also more user friendly than Belzona 1321, the customer switched to Belzona 1331 for lining their pumps. The application contractor used Belzona 1321 for years and after the application of Belzona 1331, commented that the new system is more user friendly and easier to apply.
