BELZONA REPAIRS WIRE DRAWING MACHINE

ID: 5637

Customer Location: *Copper Wire Industry, Northeastern USA*
Application Date: *2011, 2012, 2013*

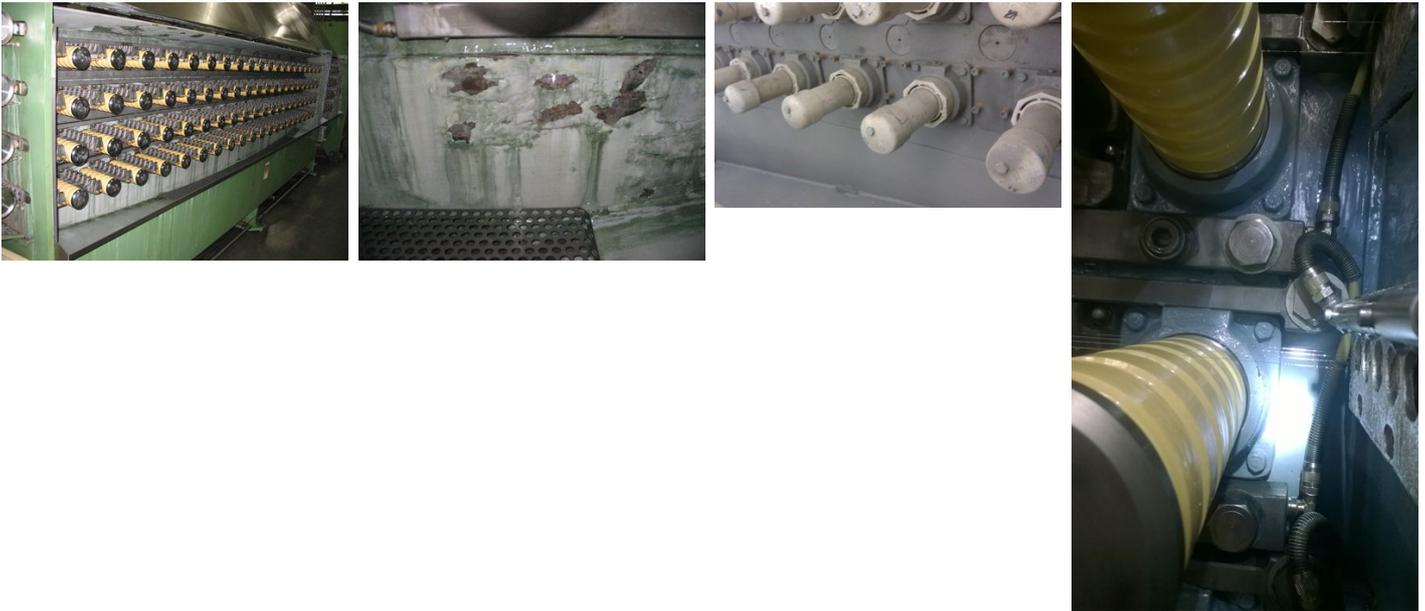
Photograph Descriptions

Corrosion cells in the drawing machine interfere with proper gaging and wire conductivity which can ruin an entire run of a speciality cable, in addition, affect plant production and cause quality problems with the finished product.

- * Overview of the wire drawing machine ,
- * Corrosion cells in the sump of the drawing machine ,
- * Blast cleaned surface before coating ,
- * Close up of coated surface after 2 years of operation, still perfect! ,

The substrate was cleaned by blasting to a near white finish standard SSPC-10. After surface preparation, Belzona 1341 was properly hand applied in accordance with the relevant IFU.
