# BELZONA HIGH TEMPERATURE LINING FOR NEW AUTOCLAVE

ID: 5641

Customer Location: Vessel Fabricator, Flums, Switzerland  
Application Date: October, 2014

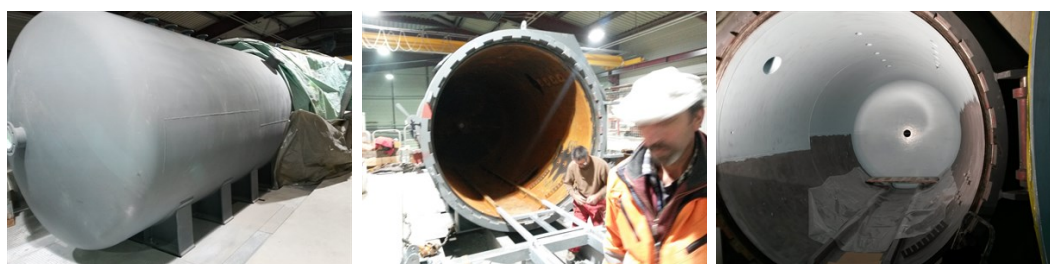
## Photograph Descriptions

- \* Outside view of autoclave ,
- \* Autoclave ready for grit blasting ,
- \* Lining application in action ,

The application was carried out in accordance with Belzona Know-How System Leaflet TCC-5. After grit blasting to SA 2.5 a two-coat system of Belzona 1593 was hand applied to an area of 45m<sup>2</sup> (484 ft<sup>2</sup>).
