FLARE STACK PROTECTED WITH HT BELZONA LINING

ID: 5656

Industry: Oil & Gas
Application: TCC-Tanks and Chemical Containment Areas
Substrate: Steel
Products: * Belzona 1523 ,

Customer Location: Singapore
Application Date: May 2015

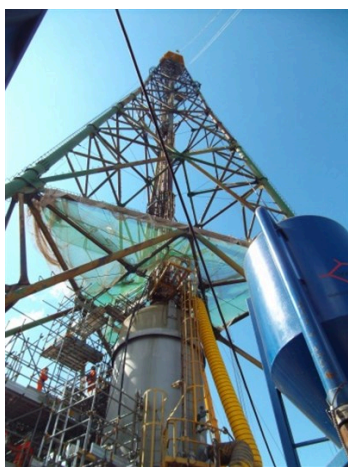
- * Flare Stack ,
- * Application monitored ,
- * Spin spray set up ,
- * Application complete ,

The Flare Stack required a corrosion protection to withstand temperatures of up to 120°C (250°F). The Flare Stack is approximately 1 m (3.2 ft) in diameter and 100 m (328.1 ft) in height.

The application was carried out in accordance with Belzona Know-How System Leaflet TCC-5. After a high pressure jet-wash, the surface was prepared with spin-blasting and followed by 3 coats of Belzona 1523. The spin spray application of approximately 300 L of product was monitored via screens.
