RISER BOOT TOPPING PROTECTED WITH BELZONA

ID: 5668

Customer Location: Production Platform, North Sea, UK
Application Date: July 2015

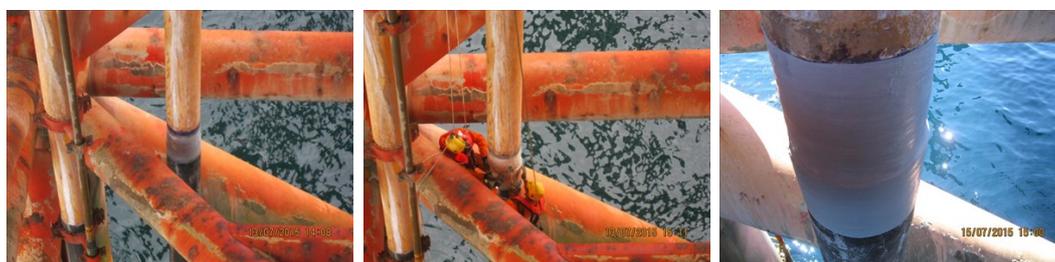
Photograph Descriptions

- * Substrate prepared for application ,
- * Application of the first layer of Belzona 3411 ,
- * Completed application ,

The square edge of the previously used Neoprene sheet allowed water to sit on the edge and penetrate underneath the sheet, resulting in severe corrosion.

The application was carried out in accordance with a modified version of Belzona Know-How System Leaflet SOS-21. After cutting back the loose Neoprene cladding and preparing the surfaces, Belzona 1321 was applied to the steel riser and blinded with Belzona 9231 (Surefoot Aggregate) to provide an anchor pattern for the application of Belzona 3411. Belzona 3911 was applied onto the Neoprene to achieve adhesion before the Belzona 3411 system was applied to bridge over the steel/neoprene junction. A bond breaker tape was applied at the junction to optimise movement at this point.
