# BELZONA PROTECTS OIL PIPE LINES

ID: 570

Industry: Oil & Gas  
Application: VPF-Valves, Pipes and Fittings  
Substrate: Carbon steel  
Products: \* Belzona® 5891 (HT Immersion Grade) ,

Customer Location: Oil production company, Egypt  
Application Date: December 2003

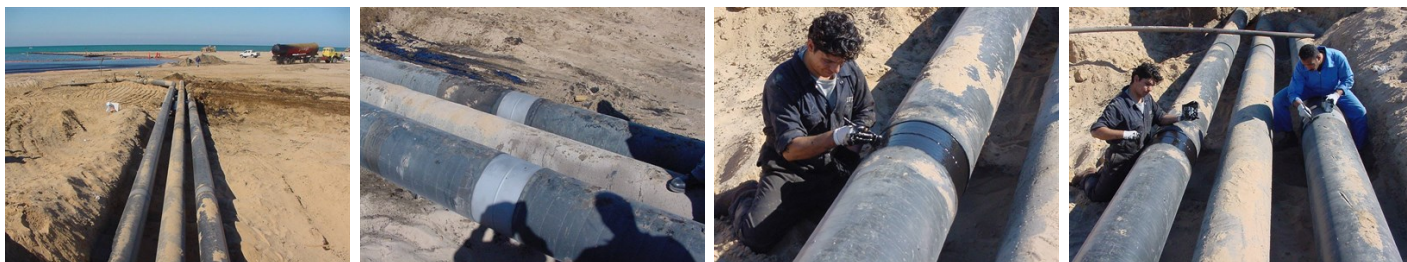
## Photograph Descriptions

Welding seams of the pipe lines need to be protected from corrosion.

- \* Crude oil pipe lines ,
- \* Welding seams of the pipe lines ,
- \* Applying Belzona® 5891 ,
- \* Application carried out on all welding seams of the pipe line ,

Pipe line welding seams were weak due to welding and need to be protected from corrosion that will be accelerated due to salts in air from the sea and high temperature. Belzona provides this protection.

Application was carried out in accordance with Belzona Know-How System Leaflet VPF-2.
