BOSCH CHAINLESS DIFFUSER COATED WITH BELZONA

ID: 5703

Customer Location: Sugar Mill, Illovo Ubombo, Swaziland
Application Date: 2010

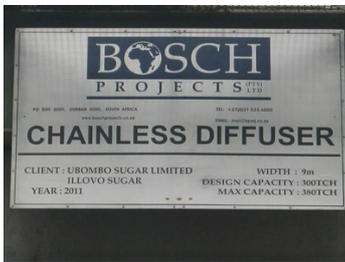
- * Chainless Diffuser designed by Bosch & Associates ,
- * General view of the sugar plant ,
- * Structural Steelwork coated with Belzona 5891 ,
- * Steam inlet pipes coated with Belzona 1391 ,

A brand new Chainless Diffuser designed by Bosch & Associates was built on site at Illovo Ubombo in Swaziland. The entire internal structural steel work and piping required an erosion and corrosion resistant coating applied to the new steel prior to assembly.
