# CREATING CUTLASS BEARINGS WITH BELZONA

ID: 577

Customer Location: Water/Electricity Authority in Qatar  
Application Date: 2000-ongoing

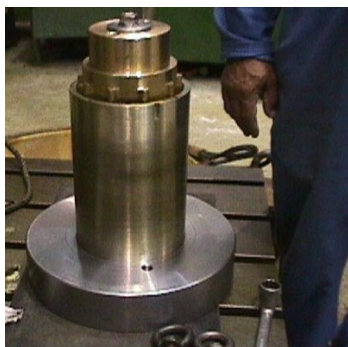
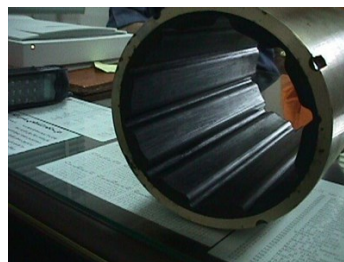
Original bearings were being worn out rapidly by the high sand content in the water.

- \* Accurate mold created to form the bearings ,
- \* Belzona Elastomer being poured into the mold ,
- \* Completed bearing ,

Over 300 bearings have been cast. Reclaiming the original sleeve allows new bearings to be produced at a fraction the cost of new ones. In addition the life of the Belzona cast bearings was found to be longer than the originals.
