BELZONA REFURBISHES ALL VALVES DURING F.S.O. REFURBISHMENT

ID: 579

Application: VPF-Valves, Pipes and Fittings

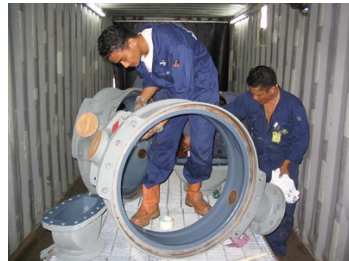
Photograph Descriptions

More than 200 valves including butterfly, globe and gate types in many sizes required refurbishment and corrosion protection during the refurbishment of the FSO.

* Some of the many valves to be refurbished Application to valve bodies underway Some of the many valve discs protected Completed gate and butterfly valve bodies ,

Application was carried in accordance with Belzona Know-How System Leaflets VPF-1 & VPF-2.

Belzona coating will protect the valves during future service exposed to sea water and crude oil as produced from the offshore oil field.
