BELZONA PROTECTS ROAD SWEEPER BOX AGAINST CORROSION

ID: 5802

Customer Location: *Waterloo, ON, Canada*
Application Date: *November 2014*

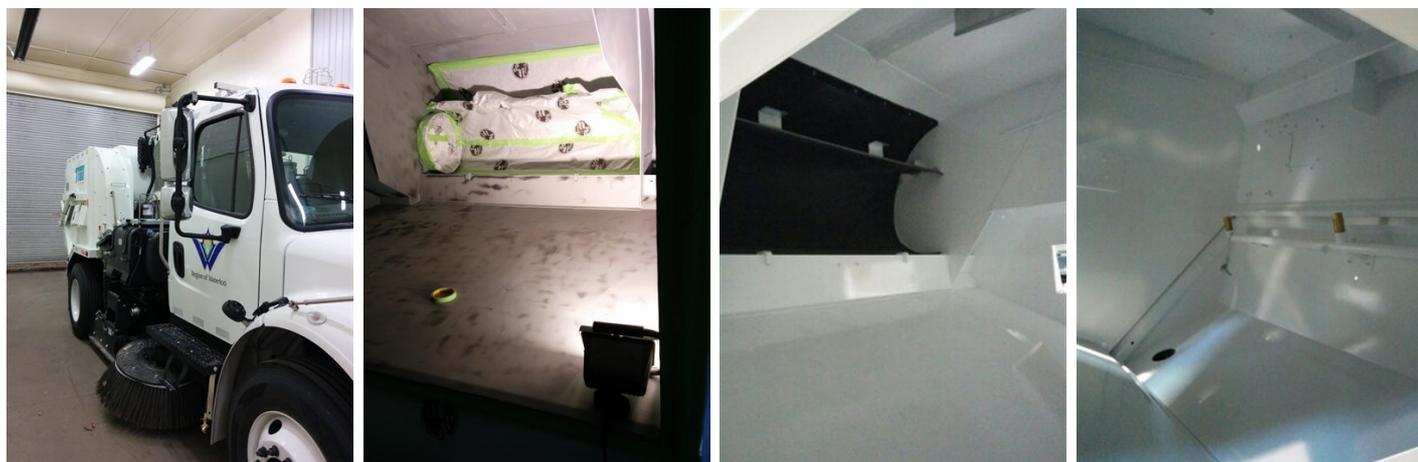
The sweeper box was suffering from corrosion from the inside, thus shortening the life of the unit.

- * View of road sweeper ,
- * Prior to application ,
- * Completed application ,
- * Completed application ,

The application was carried out in accordance with Belzona Know-How System Leaflet TCC-3 for repairing/renewing damaged linings. A high powered pressure washer was used to prepare and clean the inside of the sweeper box. Belzona 6111 was spray applied to the surface as the first coat. Within the recommended overcoat time, Belzona 5111 was spray applied as the second coat.

Belzona 6111 will not allow rust to creep at damaged areas and was applied to protect the unit from corrosion. Belzona 6111 can be sprayed or brush applied and contains 90% or more of high purity zinc content in the dry film, assuring ultimate cathodic protection. Belzona 5111 protects the unit from the abrasive action of the grit picked up off the streets. An additional benefit from using Belzona 5111 was that it aids the cleaning of the dust box after each shift. Belzona 5111 is a two-part coating designed for long term protection of metallic and non-metallic surfaces against physical, chemical and bacterial attack.
