# BELZONA BRINGS BACK LIFE TO 20 YEAR OLD TRANSFORMER

**Industry:** Power  
**Application:** TCC-Tanks and Chemical Containment Areas  
**Substrate:** Steel  
**Products:** \* Belzona 1161 (Super UW-Metal) ,  
\* Belzona 9341 (Reinforcement Tape) ,

**Customer Location:** Whitby, ON, Canada  
**Application Date:** July 2015

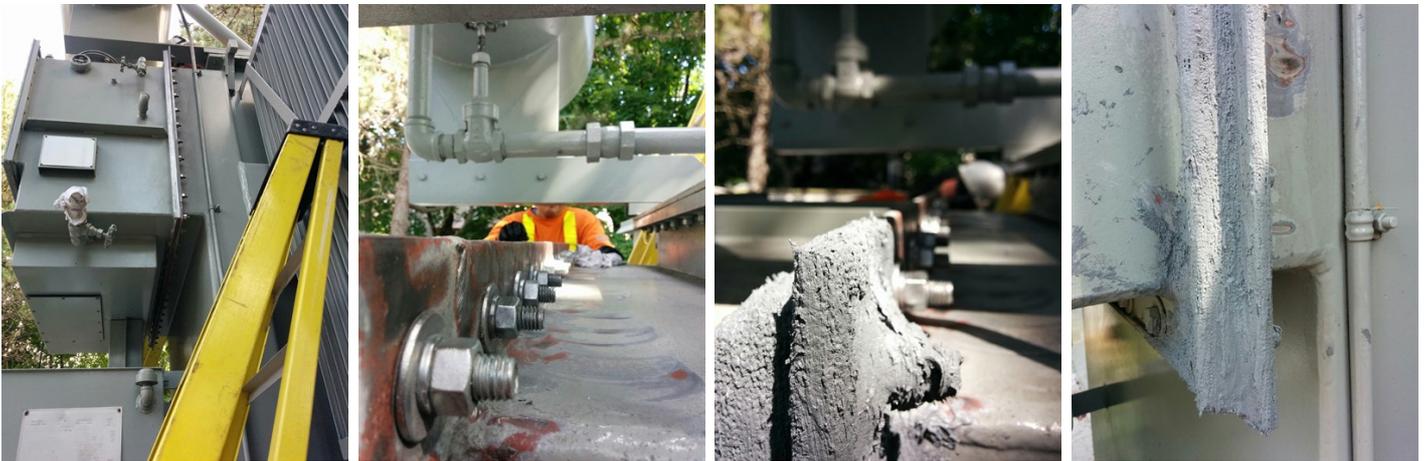
The transformer was temporarily drained and shut down due to leaking oil contaminating the surrounding ground soil, which was a safety and environmental concern.

- \* View of the transformer ,
- \* Preparation in progress ,
- \* Close up view of application ,
- \* Completed application ,

The application was carried out in accordance with Belzona Know-How System Leaflet TCC-1 for sealing crack, porous welds, bolted and riveted joints on tanks. The surface was prepared using a grinder and wire wheels electric hand tool. Belzona 1161 and Belzona 9341 was applied to the area in accordance with Belzona Instructions For Use.

Belzona 1161 is a fully machinable and surface-tolerant product that displaces fluid from the substrate and therefore can be applied and bonds firmly to wet and oily surfaces. Belzona 1161 is easily mixed, does not corrode and has good chemical resistance. One month after application we revisited the transformer. The customer was very happy that there are no more oils leaks from the transformer.
