BELZONA FILLS PITTED AREAS AND COATS 54 INCH JET VALVE

ID: 5820

54 inch jet valve

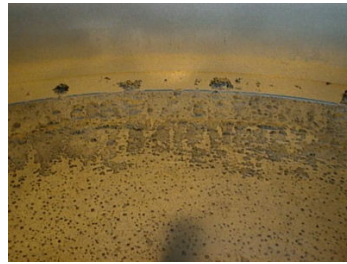
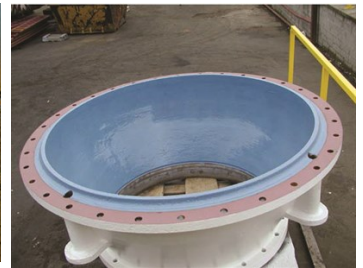
Pitted areas of a 54 inch jet valve need to be filled and coated

- * View of pitted shell ,
- * Pitting filled with Belzona 1111 ,
- * View of valve prior to application ,
- * Completed application with Belzona 1341 ,

The surface was prepared by blast cleaning to meet the minimum requirement of SA 2 1/2 or equivalent in accordance with ISO 8501-1. All edges or irregular protrusions were ground to a smooth contour and all dust, blast media and other debris were removed. All surfaces were degreased using a suitable cleaner-degreaser. The mixed Belzona 1111 was scrubbed into the pit in order to wet it out completely. Once wetted out, additional Belzona 1111 was applied to fill the pit and not just bridge . over it. An applicator was used to contour Belzona 1111 to the shape of the vessel. Once cured, Belzona 1341 was applied at a thickness of 250-300 microns. The surface preparation for the valve was carried out as it was for the pitted areas. Belzona 1341 was then applied as a stripe coat and overcoated within the 24 hours overcoating window. The applied material was visually checked for pinholes to ensure proper application.
