BELZONA PROTECTS NEW FLANGES AGAINST CORROSION

Industry: Oil & Gas
Application: GSS-Gaskets, Seals and Shims
Substrate: Steel
Products: * Belzona 3411 (Encapsulating Membrane) ,
* Belzona 8411 ,
* Belzona 9111 (Cleaner Degreaser) ,
* Belzona 9431 (Instant Bridging Tape) ,

Customer Location: Sarnia, ON, Canada
Application Date: June 2015

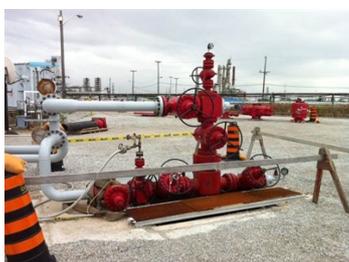
Previous flanges were suffering from corrosion. New flanges were installed and the customer wanted to avoid corrosion.

- * Prior to application ,
- * Completed application ,
- * Completed application ,

The application was carried out in accordance with Belzona Know-How System Leaflet GSS-11 for the protection of flanges and fastenings. The surface was cleaned and prepared using Belzona 9111 to remove all dirt, grease and surface contaminants. The surface where Belzona 3411 was bonded to was prepared using a wire brush. Belzona 9431 was applied to the flange, covering the gap. Belzona 8411 was spray applied to the surface and once touch dry, plastic caps were applied to the bolts of the flange. Two coats of Belzona 3411 were applied to the flanges in accordance with Belzona Instructions For Use.

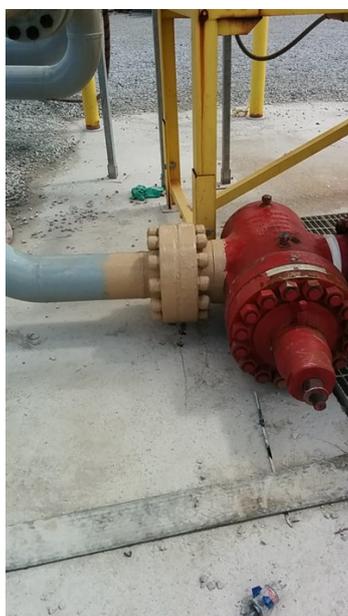
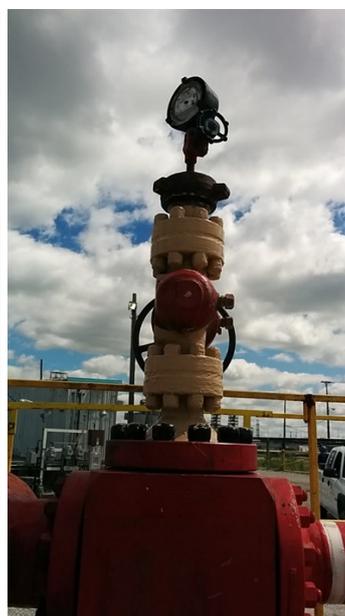
Well head flanges.

The customer chose to avoid corrosion with Belzona 3411, a flexible, peelable and resealing coating system allowing easy access to flange fastenings. This system has excellent corrosion resistance, excellent UV and environmental weathering, is quick and simple to use.
