BELZONA PROTECTS CONCRETE FLOOR AGAINST OIL CONTAMINATION

ID: 5836

Customer Location: Milton, ON, Canada
Application Date: July 2013

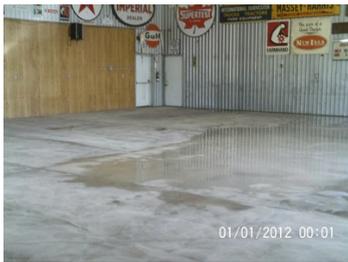
- * Prior to application ,
- * Preparation in progress ,
- * Preparation in progress ,
- * Completed application ,
