BELZONA PREVENTS CORROSION DAMAGE TO 18' RISER

ID: 5840

Industry: Oil & Gas
Application: SOS-Ships and Offshore Structures

18' riser on an offshore platform.

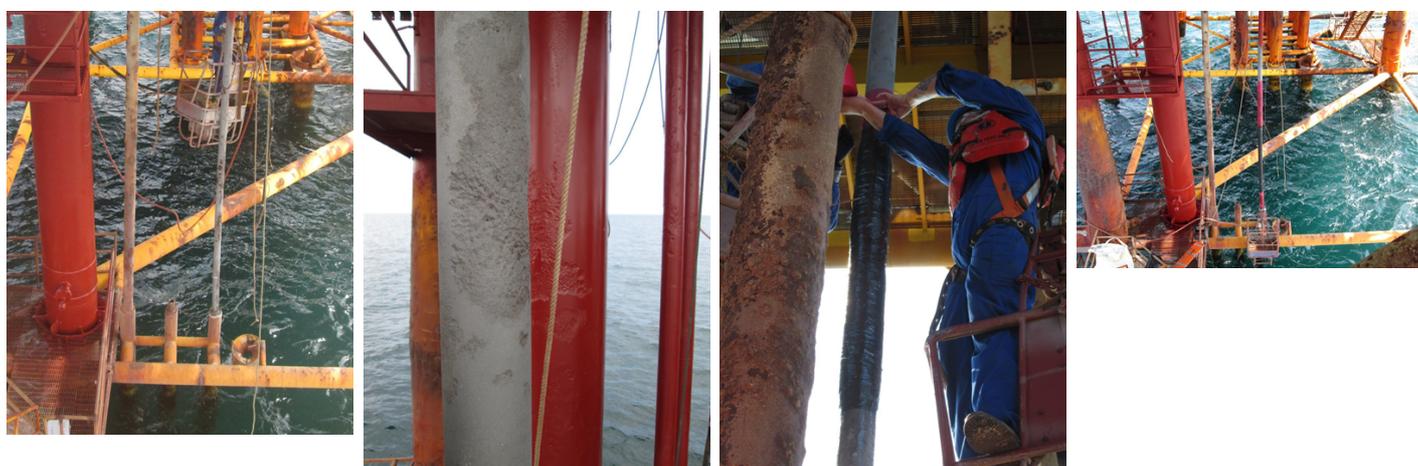
Corrosion damage to riser.

- * View of 18' riser prior to repair ,
- * Surface preparation ,
- * Application of Belzona 1982 complete ,
- * View of repair with Belzona 9382 wrapped over SuperWrap II during cure ,

The surface was blasted to the requirements of SSPC SP10 (Near White Metal). Profile measurements were checked and the surface

was cleaned and degreased with Belzona 9111. Belzona 1121 was then applied to 18' of the riser to fill pitting in order to restore the original pipe thickness. Belzona 1121 was sanded to abrade the surface and wiped down with Belzona 9111. Belzona 1982 was applied in 5 layers. Belzona 9382 was wrapped over the Superwrap II application area to consolidate and compress during cure.

The repair and application of Belzona SuperWrap II was completed in less than 8 hours, in addition to the 24 hours required for the system to cure. Belzona had quality control throughout the application and all hold points surveyed were registered.
