BELZONA GIVES ABRASION RESISTANCE TO ELBOW

ID: 5911

Application: *SHM-Solids Handling Machinery*

Worn pipe elbow

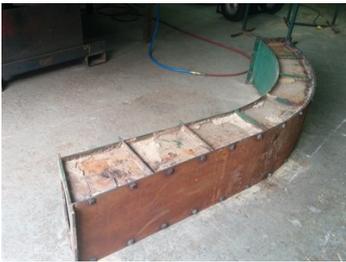
Blown wood particles create loss of wall thickness due to abrasion, eventually leading to blow-outs and loss of production.

- * General view of elbow ,
- * Application of Belzona 1812 to replaceable back ,
- * Close up of application of Belzona 1812 to elbow ,
- * Completed application ,

The application was carried out in accordance with Belzona Know-How System Leaflet SHM-8 for rebuilding worn pipe elbows. Belzona 1812 was selected as the appropriate Belzona material and applied to the wear areas of the elbow and the replaceable back, keeping within the designated wearing surface. The application was completed using a rigid applicator.
