BELZONA EXTENDS THE LIFE OF LIME SLURRY ELBOWS

Industry: Power
Application: VPF-Valves, Pipes and Fittings
Substrate: Fiber Reinforced Plastic (FRP)
Products: * Belzona 1311 (Ceramic R-Metal) ,
* Belzona 9811 ,
* Belzona 1811 (Ceramic Carbide) ,
* Belzona 1812 (Ceramic Carbide FP) ,

Customer Location: Power Plant, Illinois, USA
Application Date: Spring 2015

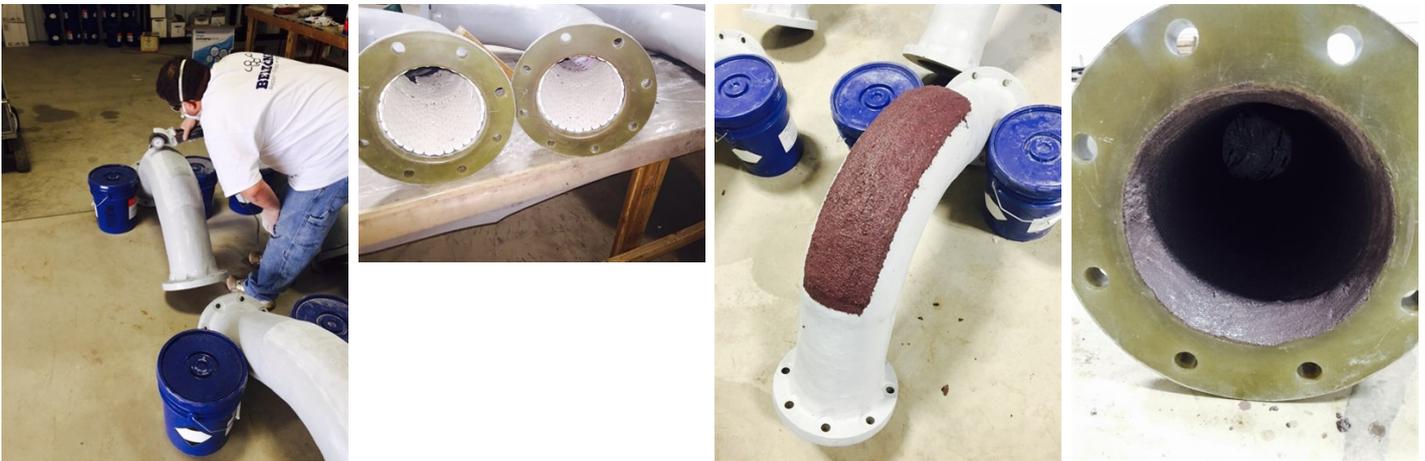
Photograph Descriptions

FRP elbows were starting to get holes as a result from abrasion from the slurry.

- * Surface preparation ,
- * View of the inside and application of Belzona 9811 tiles ,
- * Finished backing ,
- * Belzona 1812 was sloped over and into the tile to not leave an edge for the lime slurry to get under ,

The customer had the elbow's inner diameter made 1/2" bigger to allow for the thickness of the applied Belzona products. This was done to avoid the original diameter to become enclosed, which would create a smaller area of the inner diameter and create more vortex that would result in the elbows wearing faster. The surface preparation was carried out using a MBX bristle blaster. Then, a

thin layer of Belzona 1311 was used to bond the Belzona 9811 tiles in place. Belzona 1812 was then used as a grout. The customer also asked we make a thick tiled area on the back of the elbow to see if it would result in lasting longer.
