# BELZONA 7111 PROVIDES CHOCKING TO PROPULSION ENGINE ON FISHING BOAT

ID: 5919

Customer Location: *Lima, Peru*  
Application Date: *August 2015*

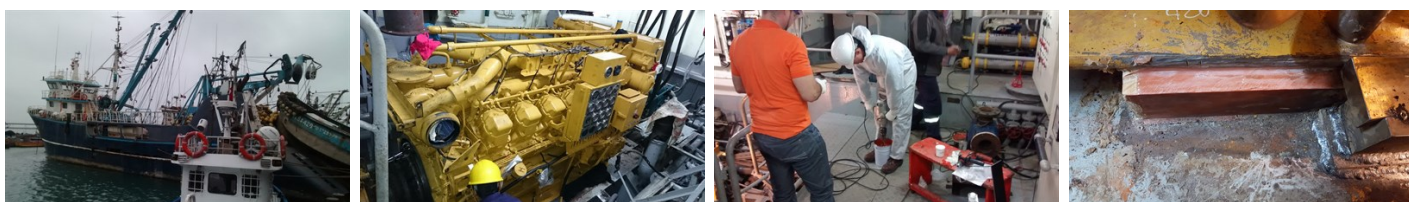
- \* Fishing boat with 500 tons of storage ,
- \* View of the main propulsion engine ,
- \* Mixing Belzona 7111 ,
- \* Port stern chock finished; the engine has 4 chocks ,

Main engine base of the propulsion system on the fishing boat with 500 tons of storage.

The application was carried out in accordance with Belzona Know-How System Leaflet GSS-12, BEL CIS 100 with ABS certification and Belzona 7111 IFU.
