BELZONA 7111 PROVIDES ALIGNMENT TO MAIN ENGINE ON BOAT

ID: 5921

Customer Location: Peru
Application Date: August 2015

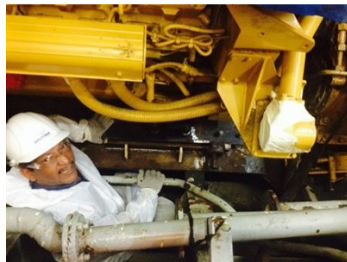
- * Belzona 7111 on board ,
- * Chock at engine base ,
- * Detail of caring before pouring ,
- * Verifying the correct engine-gearbox alignment ,

Main engine base of the propulsion system on the fishing boat.

After pouring Belzona 7111 in four chock casings and curing, the alignment was verified within the acceptable and projected range. The process of pouring the liquid polymer offers benefits while replacing the manufacturing of metal shims that do not guarantee 100% support, are costly, needs time and corrections, which requires more days of downtime with no production and would result in a great loss in costs. Belzona 7111 has certification of Marine Classification of Lloyd's Register and American Bureau of Shipping.
