BELZONA KEEPS THE LIGHT RAIL ON TRACK

ID: 5930

Steel train track for the city light rail transportation system.

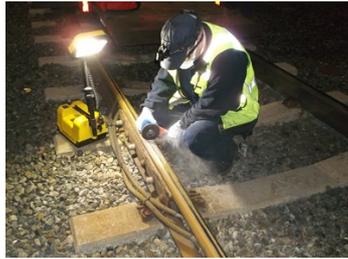
The fiberglass joint spacer was breaking down and the top of the track was weakening and getting pushed into the void.

- * Light Rail Joint; note the stress crack on the bottom-center of the joint ,
- * Grinding to remove the fiberglass and prepare the surface ,
- * Application of Belzona 1221 ,
- * Completed application ,

A cutting wheel was used to remove the damaged fiberglass piece and then a grinding wheel was used to roughen and prepare the two surfaces. Duct tape was applied on either side of the repair for fast and easy clean up. An appropriate amount of Belzona 1221 was mixed and first worked into the two faces of the track. Then, the material was pushed in from the top until excess squeezed out on both sides. The excess material was scraped off, leaving it a little proud. A grinder was then used to machine it down to the proper profile.
