BELZONA 7111 PROVIDES CHOCKING TO DRIVE SYSTEM ON FISHING BOAT

Industry: Marine

Application: GSS-Gaskets, Seals and Shims

Customer Location: Fishing Company, Peru

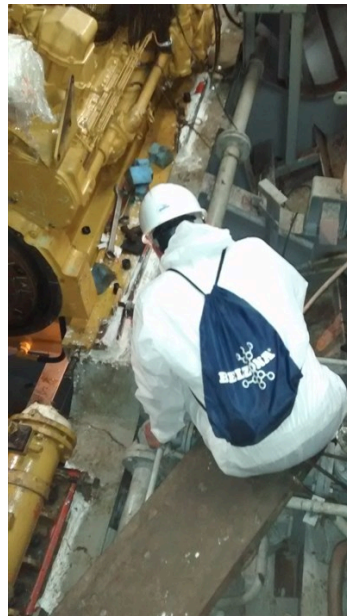
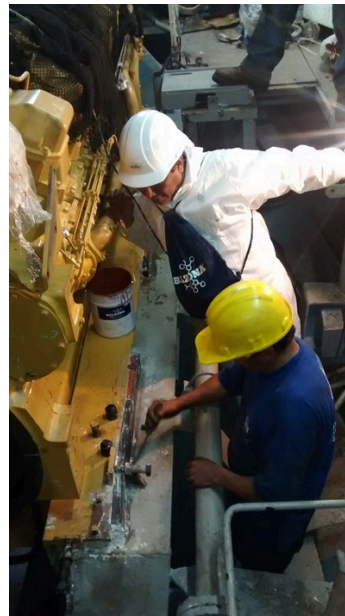
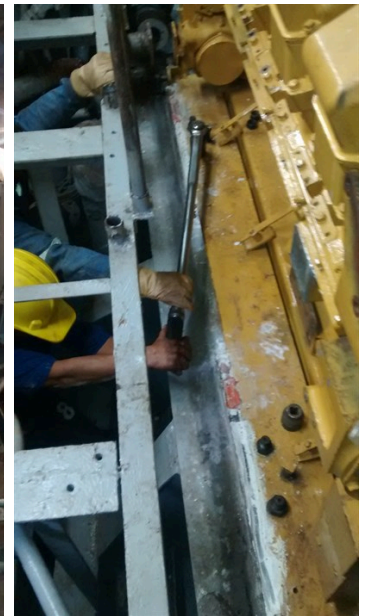
Photograph Descriptions

- * View of the engine and machine room ,
- * Inspection of the box and engine chocks ,
- * Completing work on the engine chocks ,
- * Adjusting bolts with torque wrench for precision. ,

The four chocks for the engine and two for the box were carried out by pouring Belzona 7111 which has American Bureau of Shipping certification. Once the product cured completely, it underwent compression with weight and adjustment of anchor bolts maintaining the specified parameters of alignment. It has been proven that Belzona 7111 has a lower cost than other chocking materials.
