BELZONA CALLED IN FOR TOUGH FLOOR REPAIRS

ID: 5942

Industry: Buildings & Structures
Application: FPA-Floor Problem Areas
Substrate: Concrete
Products: * Belzona 4111 (Magma-Quartz) ,
* Belzona 4911 (Magma TX Conditioner) ,

Customer Location: Clarksville, TN, USA
Application Date: September 2015

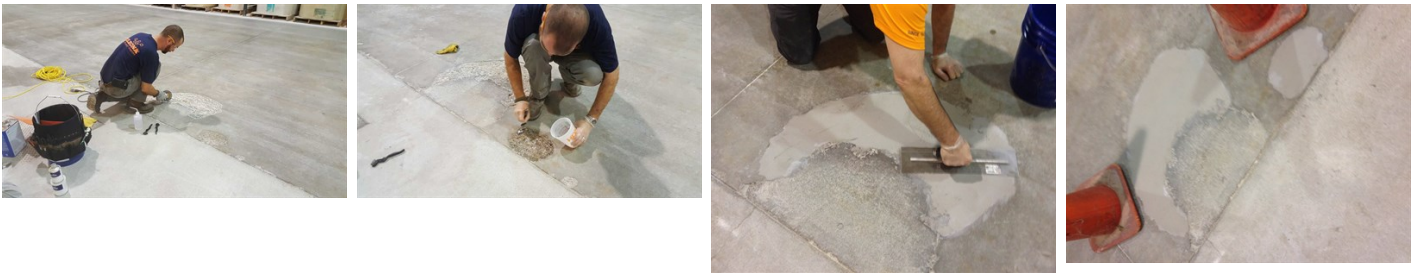
Photograph Descriptions

The customer was having difficulty finding materials to repair the damaged concrete floors and that would hold up to the weight of the 15,000 pound automated robots they used to shuttle materials around their production facility.

- * Preparing the area with a grinder ,
- * Conditioning with Belzona 4911 ,
- * Applying Belzona 4111 by trowel ,
- * Completed application ,

The application was carried out in accordance with Belzona Know-How System Leaflet FPA-1. The repair area was cleaned using acetone and a rotary wire wheel. An angle grinder was then used with a masonry wheel to prepare the area to allow for an application of at least 1/4" of Belzona 4111. The area was then given a final cleaning with acetone. Belzona 4911 was used to condition the substrate and Belzona 4111 was then trowelled into place and smoothed out. In the warm environment the repair was ready for service in about 4 hours.
