# BELZONA REPAIRS LEAKING TANK AT FOOD FACTORY

ID: 5977

**Customer Location:** Food Producer, Skopje, Macedonia  
**Application Date:** November 2015

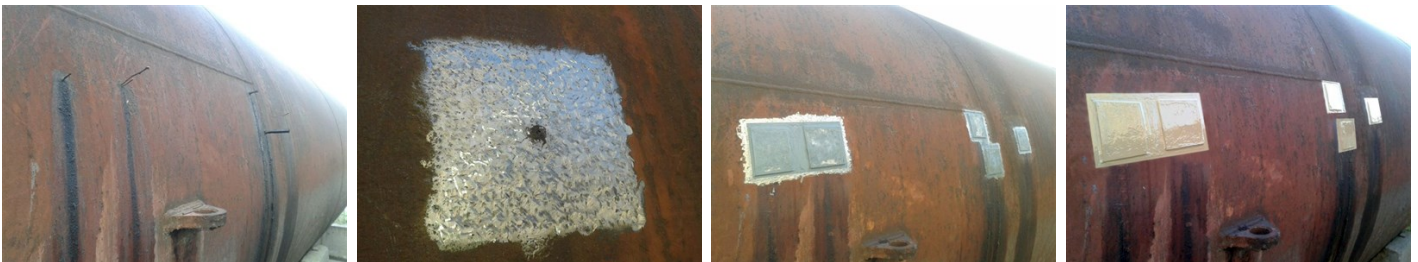
## Photograph Descriptions

Horizontal steel tank was suffering from corrosion, which had led to through-wall defects, all located at the bottom of the vessel. The customer had been using wooden pegs to plug the holes.

- \* Wooden pegs plug leaking tank ,
- \* Surface preparation around defect ,
- \* Metal plates bonded with Belzona 1161 ,
- \* Repairs coated with Belzona 5811 ,

The application was carried out in accordance with Belzona Know-How System Leaflet TCC-1. Belzona 1161 was selected to bond metal plates over the defects. Each of these areas were then coated with Belzona 5811 to protect from further corrosion damage.

The customer was after a quick fix as opposed to a long-term solution. Also, the tank was rotated in order to relocate the holes in the upper surface of the tank, thus preventing pressure leaks. Belzona 1161 surface tolerant properties ensured high bond strength to the contaminated tank surface.
