BELZONA SUCCEEDS WHERE NOBLE METALS FAIL

Application: SHM-Solids Handling Machinery

Ferrite wheel mixer

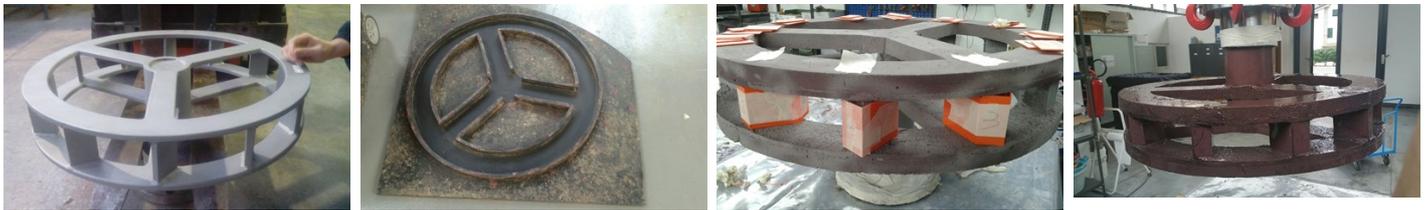
Photograph Descriptions

Severe dry abrasion from ferrite powder was wearing mixer wheel despite being constructed from expensive noble metal alloy. Belzona consultant recommended lining a carbon steel wheel with Belzona.

- * Carbon steel wheel after grit blasting ,
- * One of the templates used for the application ,
- * Application in progress ,
- * Completed application ,

The application was carried out in accordance with a modified version of Belzona Know-How System Leaflet SHM-13. Prefabricated custom made templates were used to carry out the application of Belzona 1811 at a thickness of approximately 10mm on all surfaces of the wheel. Belzona 4151 was then applied to provide a glossy finish.

Belzona was able to solve a substantial problem of dry abrasion in the presence of strong concentrations of chlorides. In fact, using a carbon steel wheel coated with Belzona 1811 quadrupled component's life to 4000 hours. The original noble metal alloy wheels lasted 1000 hours in service.
