# BELZONA SUCCEEDS WHERE NOBLE METALS FAIL

Application: SHM-Solids Handling Machinery

Customer Location: Manufacturer, Varese, Italy

Ferrite wheel mixer

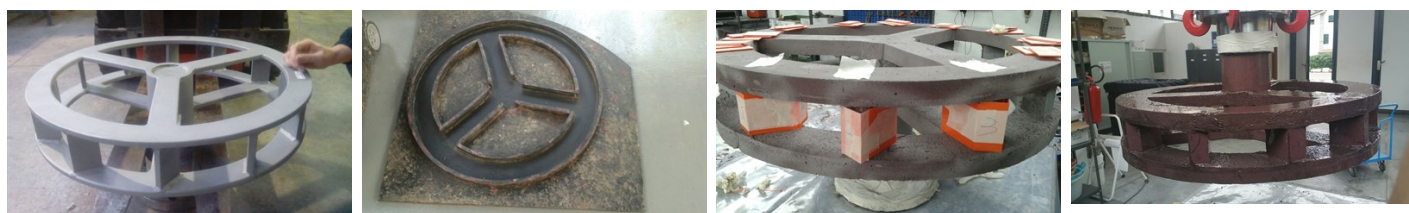
## Photograph Descriptions

Severe dry abrasion from ferrite powder was wearing mixer wheel despite being constructed from expensive noble metal alloy. Belzona consultant recommended lining a carbon steel wheel with Belzona.

- \* Carbon steel wheel after grit blasting ,
- \* One of the templates used for the application ,
- \* Application in progress ,
- \* Completed application ,

The application was carried out in accordance with a modified version of Belzona Know-How System Leaflet SHM-13. Prefabricated custom made templates were used to carry out the application of Belzona 1811 at a thickness of approximately 10mm on all surfaces of the wheel. Belzona 4151 was then applied to provide a glossy finish.
